Manhole Inspection Summary

Manhole # S11EE1014MH

Insp Date: **9/24/07 11:50 AM**

Location Address: **RR TRACKS**

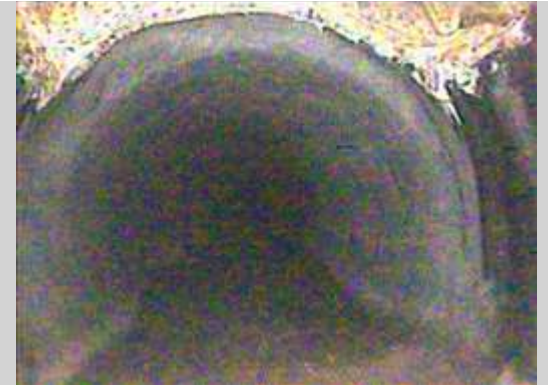
12 O'Clock Outflow

15 in. Circular Gravity Sewer
Pipe Out @ 12 O'Clock

Pipe Height: **15.6** (in.) Rod and Bar (Angled)
Pipe Material: **Clay** ☐ Pipe Lined
Invert Depth: **12.75** (ft.) Flow Characteristics: **Fast**
Deposits: ☒ None ☐ Mud ☐ Sludge ☐ Debris ☐ Grease
Silt Depth: (in.) Deposits Extent:
Infiltration: **None** Pipe Seal Cond: **Sound**

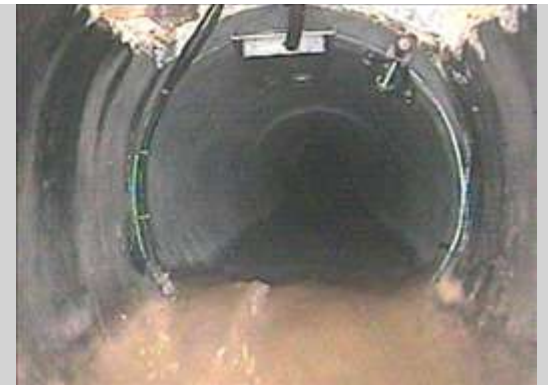
6 O'Clock Inflow

15 in. Circular Gravity Sewer
Pipe In @ 6 O'Clock

Pipe Height: (in.) Direct
Pipe Material: **Clay** ☐ Pipe Lined
Invert Depth: **12.83** (ft.) Flow Characteristics: **Fast**
Deposits: ☒ None ☐ Mud ☐ Sludge ☐ Debris ☐ Grease
Silt Depth: (in.) Deposits Extent:
Infiltration: **None** Pipe Seal Cond: **Sound**
